# RAPID CONCRETE REPAIR FOR ICE RINK

## Epoxy Aggregate Repair Ready for Game Time in 48 Hours

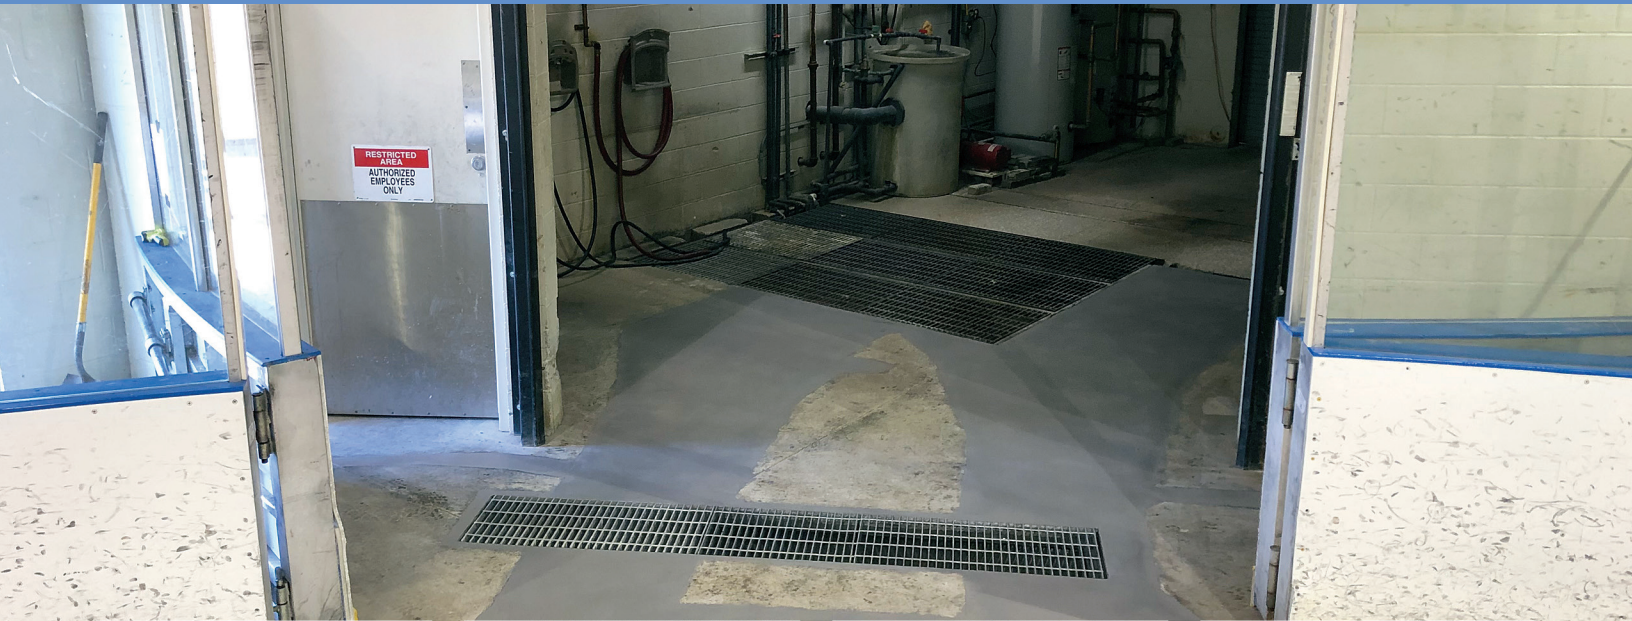
Concrete floor damage from traffic and freeze/thaw effects.

- 1 Zamboni machines wear down concrete floors
- 2 Undersized drain pit and cracked concrete
- 3 Drain pit widened to increase capacity
- 4 Fast cure Belzona 4131 used to resurface damage

Zambonis keep the ice slick but are rough on concrete. Tire studs formed depressions in the floor of this ice rink maintenance area. Water and ice from an undersized drain pit collected in these ruts. Wheel abrasion and freeze/thaw damage caused cracking in the concrete, forming a safety hazard. BIG solved the problem quickly by enlarging the drain pit and resurfacing the floor with a high-performance, specialized (Belzona 4131) rapid cure epoxy aggregate that is far stronger than concrete. It provides excellent protection against abrasion, impact, vibration and chemical attack, proven to last for many years. The customer reopened the floor in only 48 hours.
